# epoch home report

5 Shandon Crescent  
Edinburgh  
EH11 1QE  
30/01/2026

# Single Survey

<b>Property address</b>	5 Shandon Crescent, Polwarth, Edinburgh, EH11 1QE
<b>Customer</b>	Mr & Mrs Prosser
<b>Customer address</b>	
<b>Prepared by</b>	Graham + Sibbald
<b>Date of inspection</b>	22nd January 2026

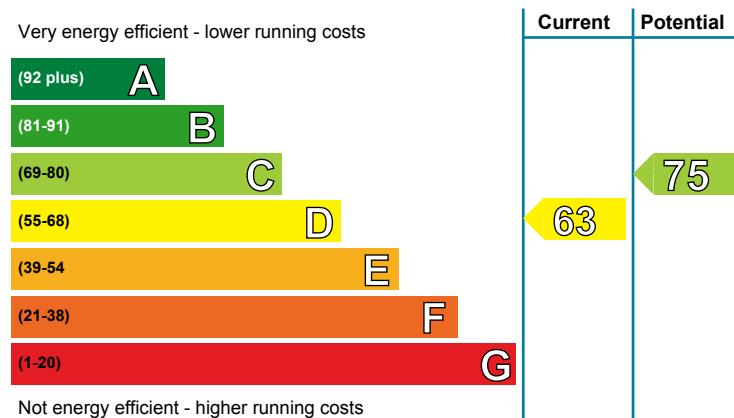
## Energy Efficiency Rating

This graph shows the current efficiency of your home, taking into account both energy efficiency and fuel costs. The higher this rating, the lower your fuel bills are likely to be.

Your current rating is **band D (63)**. The average rating for EPCs in Scotland is **band D (61)**.

The potential rating shows the effect of undertaking all of the improvement measures listed within your recommendations report.

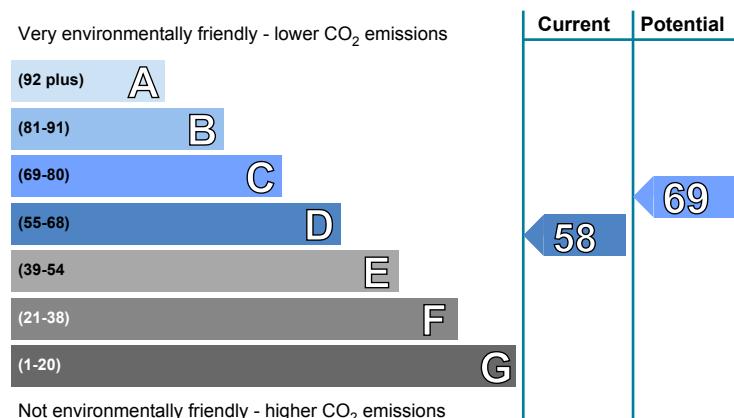
## Environmental Impact (CO<sub>2</sub>) Rating

This graph shows the effect of your home on the environment in terms of carbon dioxide (CO<sub>2</sub>) emissions. The higher the rating, the less impact it has on the environment.
